Analyze and Study on the Typical Operation Fault of Transmission Lines Composite Insulator

Li Hua, Li Qianzhu, Yang Fan, Chang Binfeng, He Jun, Yang Yang, Huang Manyi
(Li Qianzhu, Electricity transmission and inspection working area at Chengdu electric power Bureau
Maintenance Company, No.239 Xinhong Road Chenghua District Chengdu Sichuan 610051,
qianzhuli@yahoo.com)

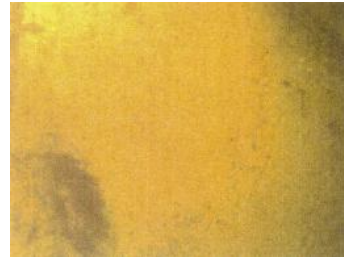
HC grade picture about hydrophobic mobility test of sample A1

According to the above hydrophobicity tests, it can be seen that the hydrophobic grades of sample A (fault insulator) and sample B (non-fault insulator) are HC3 level, and most hydrophobic grades are HC6 in hydrophobicity weakened test. The hydrophobic grades are HC3 to HC4 in hydrophobic recovery test, and the hydrophobic grades of samples are HC7 in the hydrophobic mobility test, which are much higher than the specified value. It points out that hydrophobic properties of sample A and B are significantly reduced compared to normal composite insulators, and the hydrophobic mobility is almost completely lost.

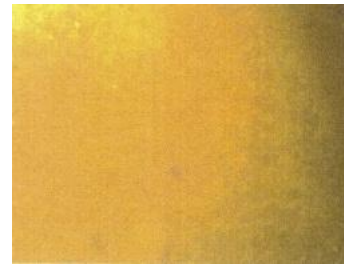
HC grade picture about hydrophobic mobility test of sample B1
